PHASE 1 REPORT FOR CONTAMINATION ASSESSMENT INVESTIGATION CHICORA
TANK FARM (CTF) CNC CHARLESTON SC
12/01/1988
NAVFAC SOUTHERN

PHASE I REPORT
CONTAMINATION ASSESSMENT INVESTIGATION

CHICORA TANK FARM

December 1988

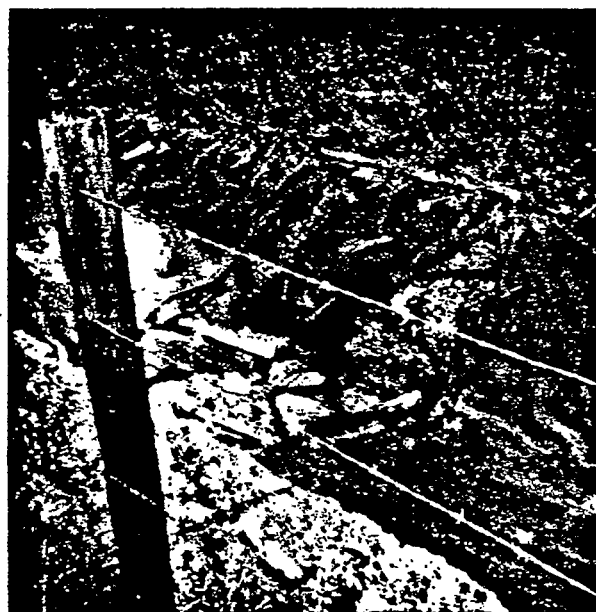
9-19-88 LINED DITCH @ CHICORA
TANK FARM, CHAS. NOTE 36" DRAIN
PIPE BELOW LINER AND WASHOUT AREA

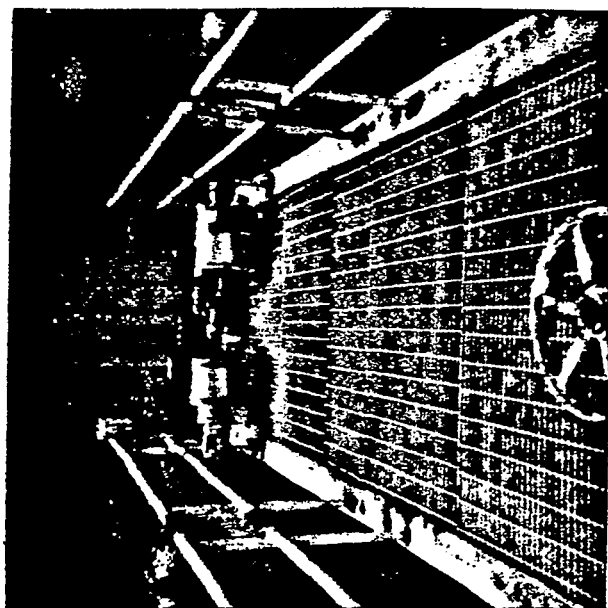
The spill containment system installed at Chicora in 1974 has not been maintained for 5-6 years. The skimmer system is inoperable and any spilled or leached product reaching the lagoon via the french drain system or otherwise is discharged directly to the adjacent creek and subsequently to the Cooper River.

9-19-88 CHICORA TANK FARM - DIKE AND SKIMMER SYSTEM BETWEEN THE TWO LAGOONS. NOTE THE SKIMMER BELTS AND MANUAL WHEEL THAT DIKES FLOW OUT TO THE CREEK.

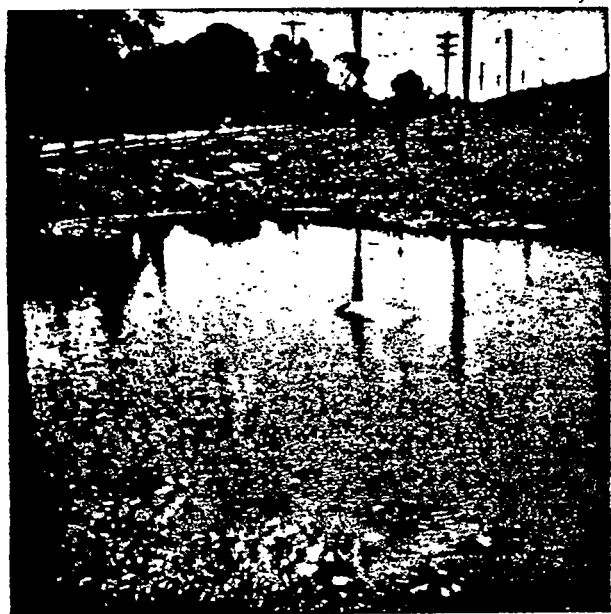
9-19-88 CHICORA TANK FARM - LAGOON ACCEPTING STREAM FROM LINED DITCH IN UPPER LEFT CORNER OF PICTURE - NOTE BUBBLES UP 30 MIL LINER IN MIDDLE OF LAGOON.

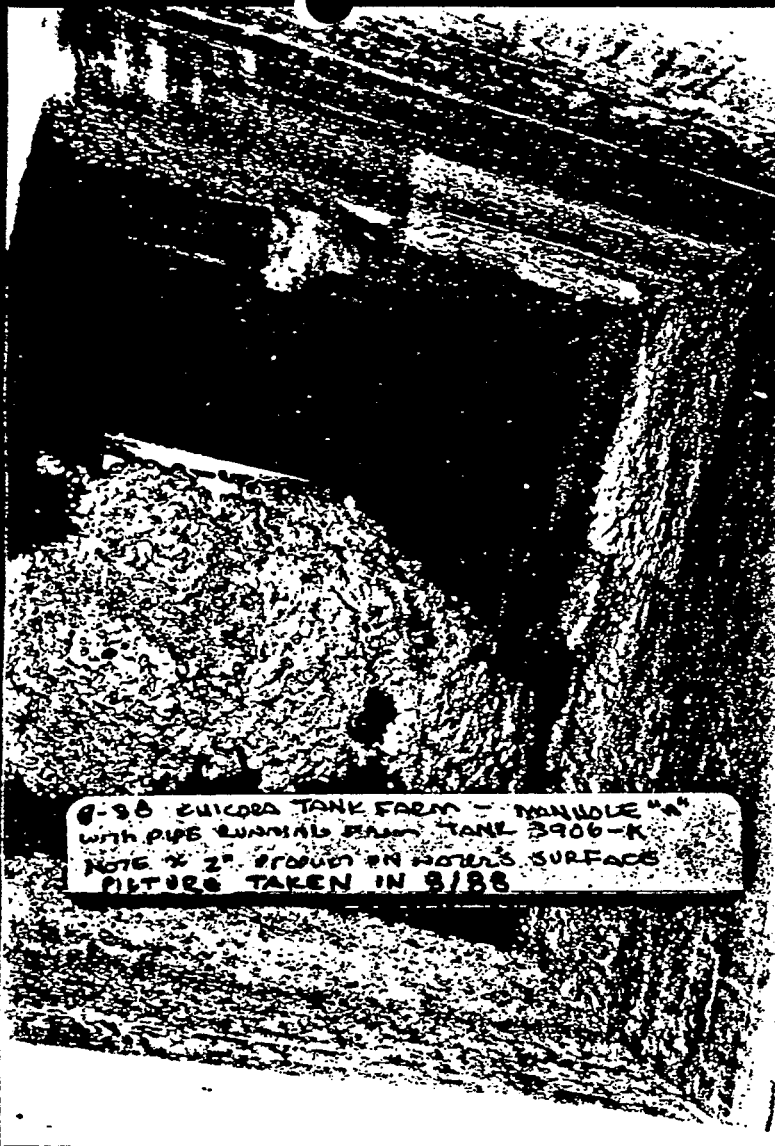
Up to two inches of a dark oily product was observed floating in manhole A (nearest the lagoon) and manhole B (near tank 3906-P). Manhole C (between tanks 3906-O and 3906-M) had a light oily sheen on the water surface. The concrete in manholes A and B was coated with a dark oily sludge below the water surface.

8-98 CHICORA TANK FARM - MANHOLE "A"
WITH PIPE RUNNING FROM TANK 3906-K
NOTE "X" 2" PRODUCT ON MORTAR SURFACE
PICTURE TAKEN IN 8/88
